# Property and Timber Pest Report

Inspection Date: 12 Aug 2025

Property Address: 1A Werrington Street Burradoo 2576

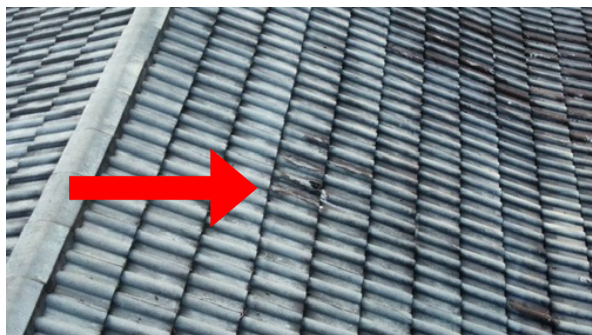
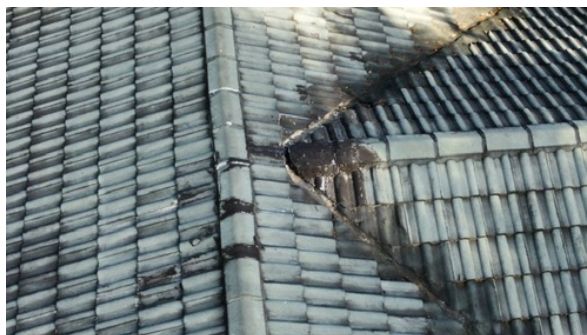
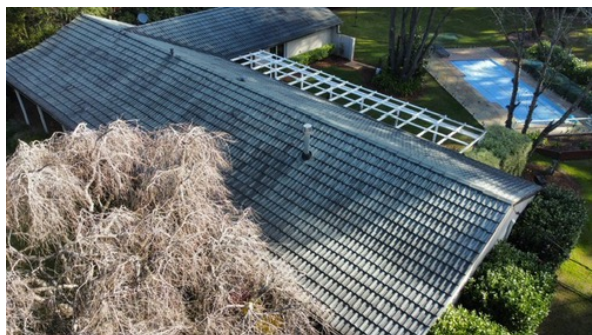
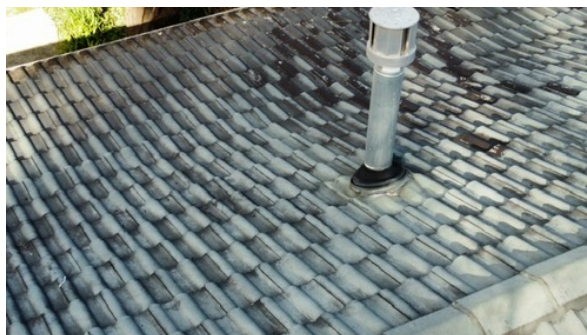
**Finding:** Damaged roof tile

There was evidence of a damaged roof tile. It is recommended to replace. There was evidence of historical restoration and re-pointing in areas. Photos for your reference.

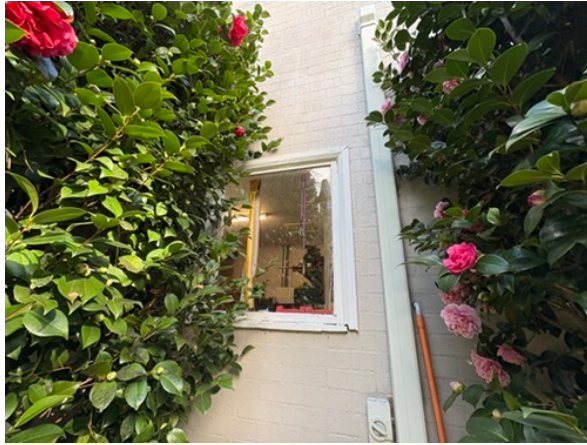
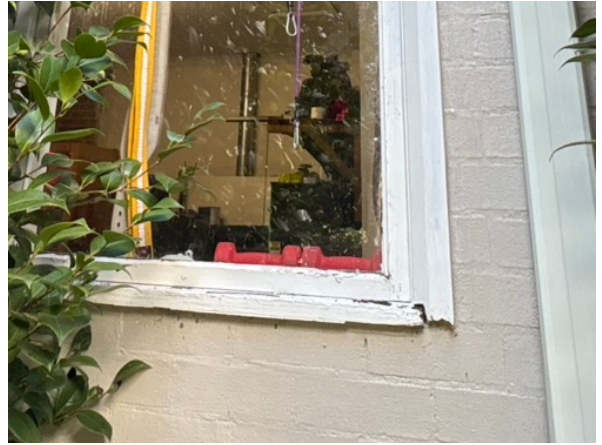
**Location:** All External Areas

**Finding:** Wood rot- window trim

Wood rot which also known as Fungal Decay, occurs when timbers and other cellulose type building materials are exposed to damp conditions on a continual basis. Replacement of affected timbers may then be a necessary step in protecting surrounding building elements from such deterioration.

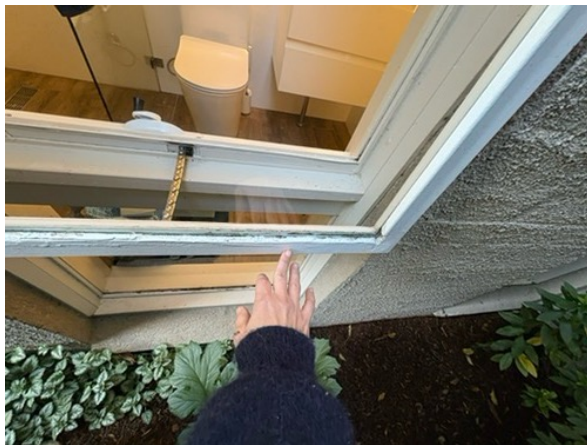
**Location:** All External Areas

**Finding:** Window- minor deterioration

The window putty appears to have deteriorated, exposing the base of the glass. It is recommended to repair.

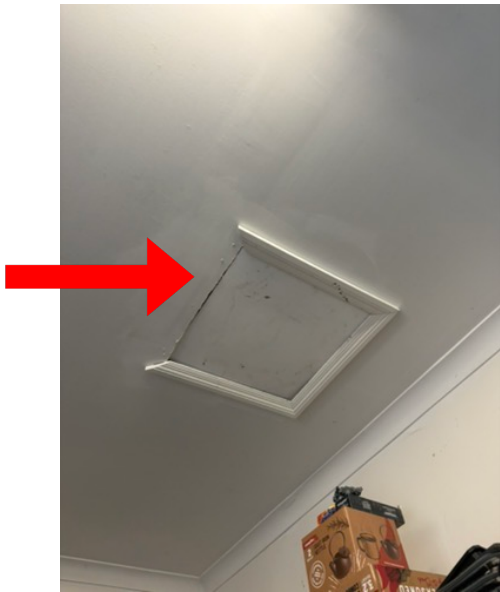
**Location:** Garage

**Finding:** Building element - Broken or damaged

The manhole trim piece is missing in this area. Breakage occurs generally when the building elements have either aged and decayed, or have been damaged whether accidental or deliberate. Repair or replacement of broken elements is advised at clients discretion.

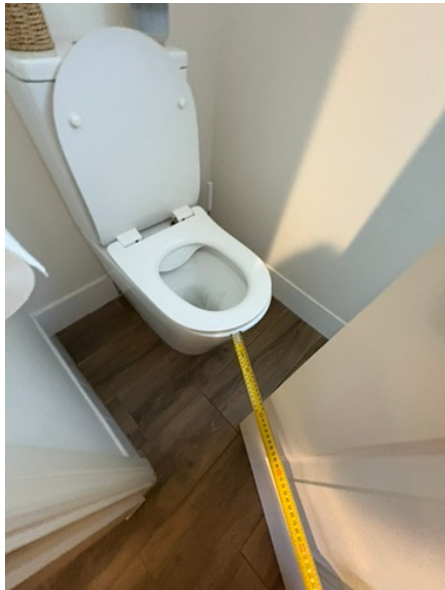
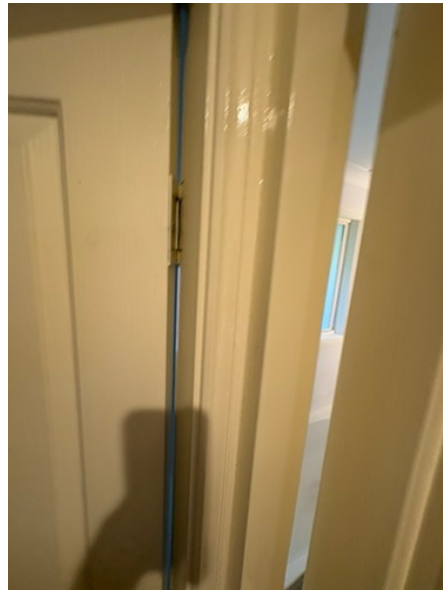
**Location:** Bathroom

The NCC contains a Performance Requirement that requires a sanitary compartment to be constructed with sufficient space or other means to permit an unconscious occupant to be removed from the compartment. The corresponding Deemed-to-Satisfy Provisions, F2.5 of NCC Volume One and 3.8.3.3 of NCC Volume Two, require the door to a fully enclosed sanitary compartment to open outwards or slide or be readily removable from the outside of the compartment, unless there is a clear space of at least 1.2 m between the closet pan and the doorway.

Note this dwelling was constructed prior to this regulation coming into effect.

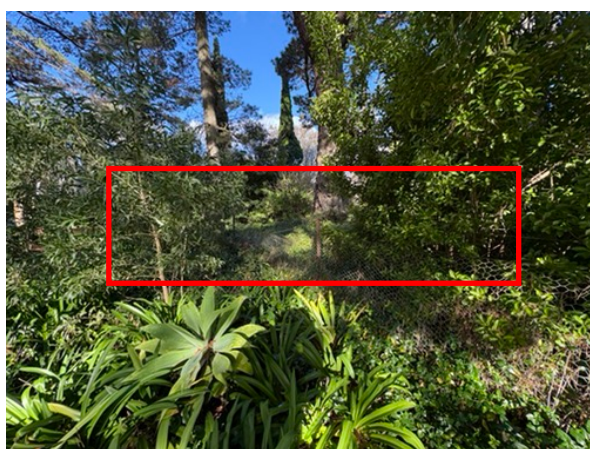
**Finding:** Fencing - Deteriorated

It was noted at the time of inspection that sections of the fencing throughout the property have deteriorated. Typically fencing deteriorates due to age or rot which is generally expected for a structure of this age, due to prolonged exposure to weather conditions. A licensed fencing contractor should be appointed to provide further advice and perform rectification works as necessary.

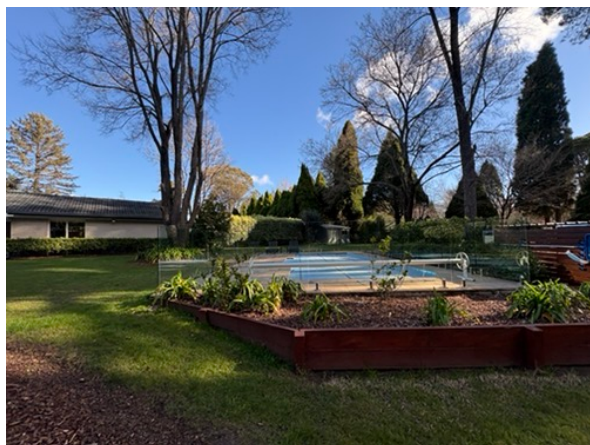
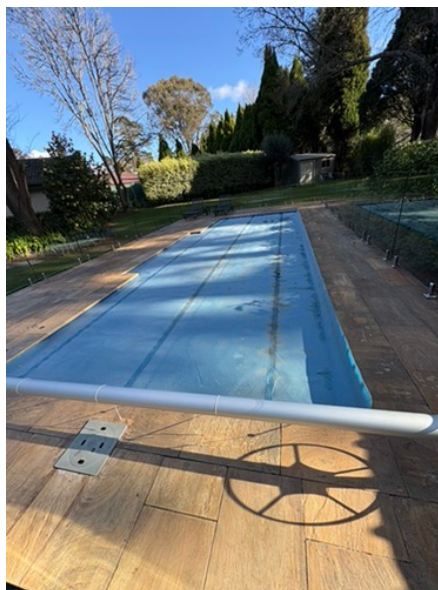
The report does not cover pool compliance and related issues. It is recommended to obtain a pool compliance certificate from a qualified pool inspector.

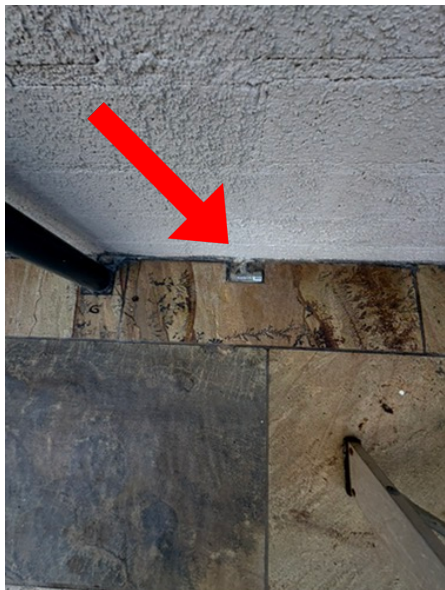
The gas connection point (bayonette) was observed to be semi-buried and tiled to its edge, limiting accessibility. This arrangement does not comply with the Plumbing Code of Australia and AS/NZS 5601.1, which require gas fittings and isolating valves to be readily accessible for operation, maintenance, and emergency shut-off. Semi-burial may also increase the risk of corrosion and mechanical damage, compromising safety.

It was undetermined whether the bayonette is functional or has been disconnected and is only a legacy element. it is recommended to engage a gas fitter to inspect and rectify if required.

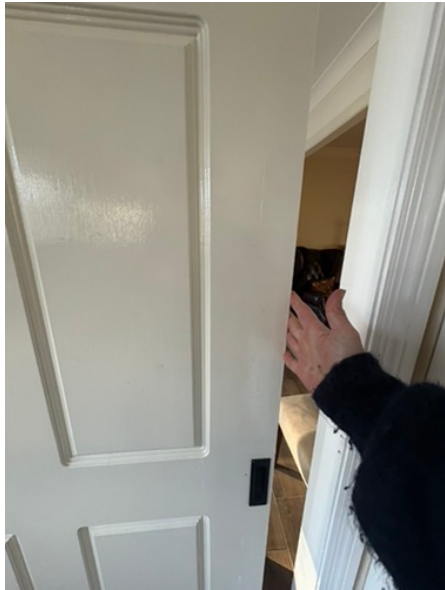
**Finding:** Door - stiff to slide

This internal door was difficult to operate at the time of inspection. Replacement of door running hardware may be required, as well as minor repairs and cleaning.

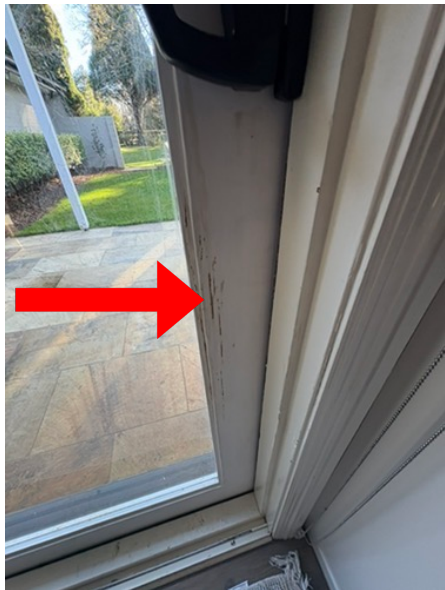
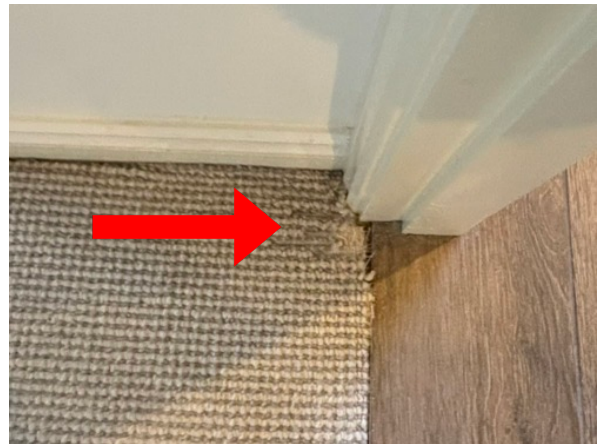
**Location:** All Internal Areas  
**Finding:** Surface - Marked

Although detracting from the overall appearance, marked, minor damage or stained surfaces do not indicate any operational or structural damage. This degree of surface damage is consistent with general wear and tear and is expected of a property of this age and condition. Marked surfaces may be left as is at client discretion, as no repairs or replacement are necessarily required for this appearance defect.

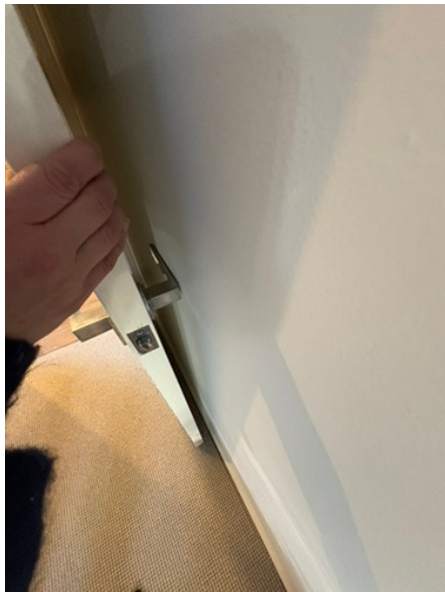
A door stop is missing in this area.  
 It is recommended to install door stops to prevent secondary damage to building elements.

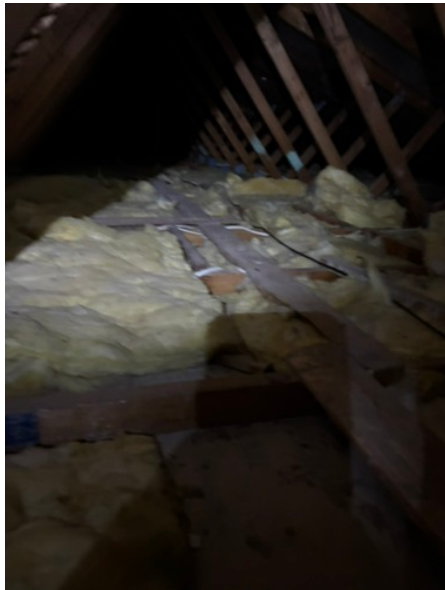
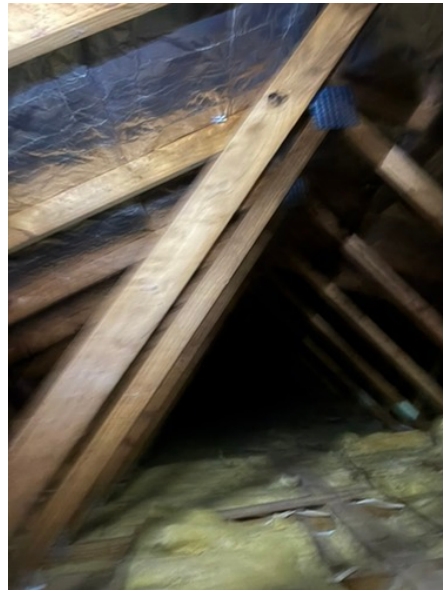
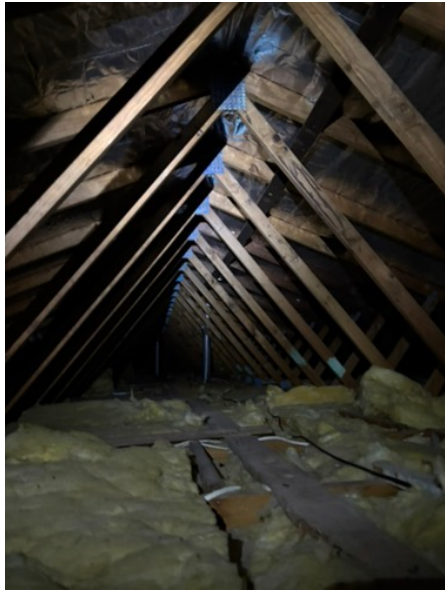
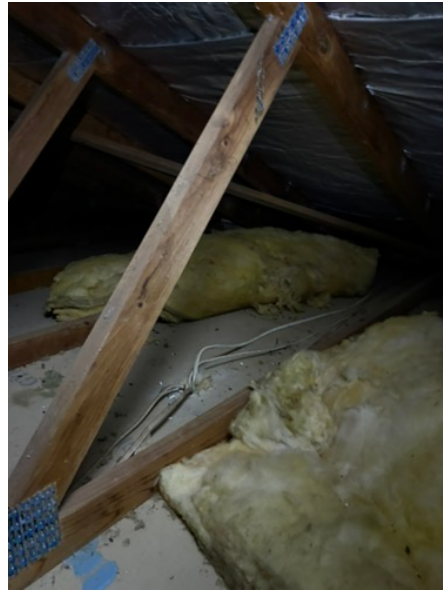
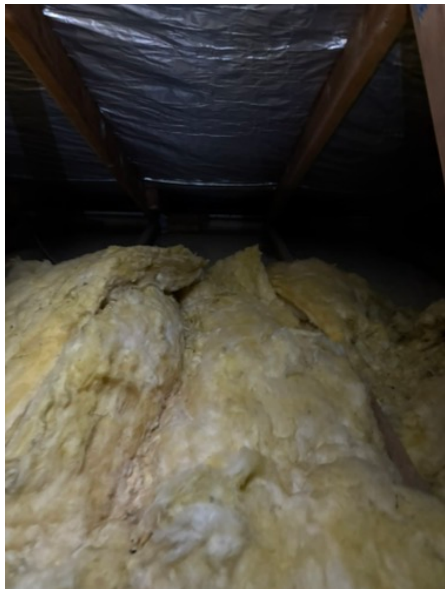
**Location:** Roofspace  
**Finding:** Sarking and insulation present  
Photos for your reference only.

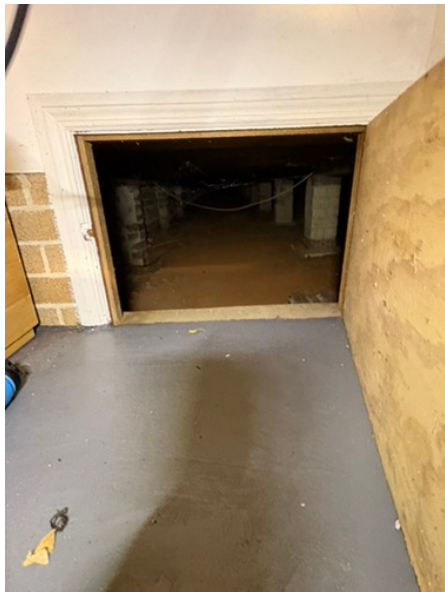
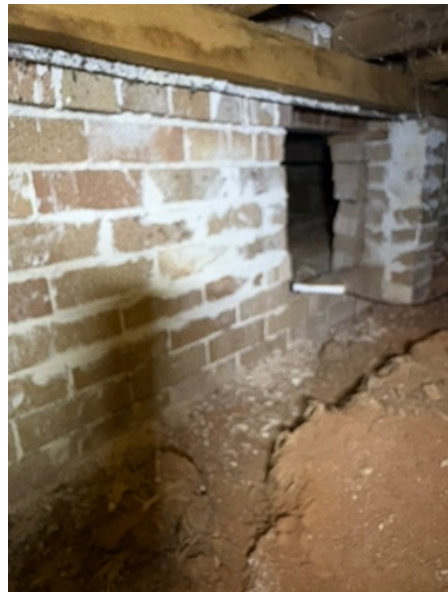
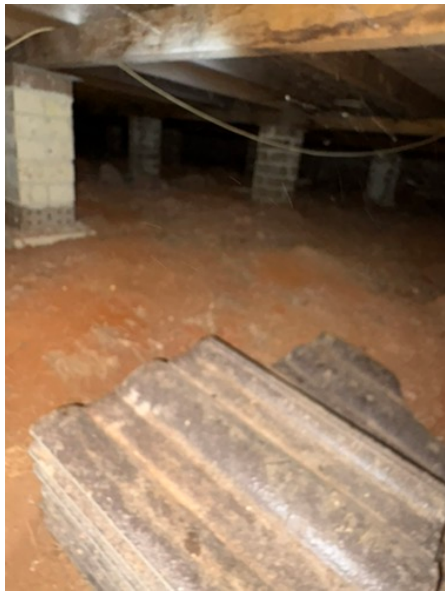
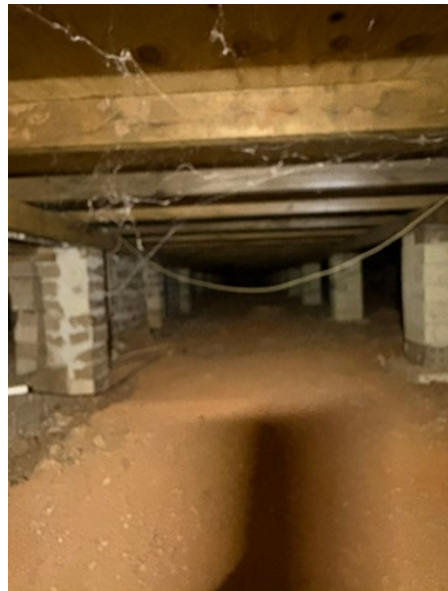
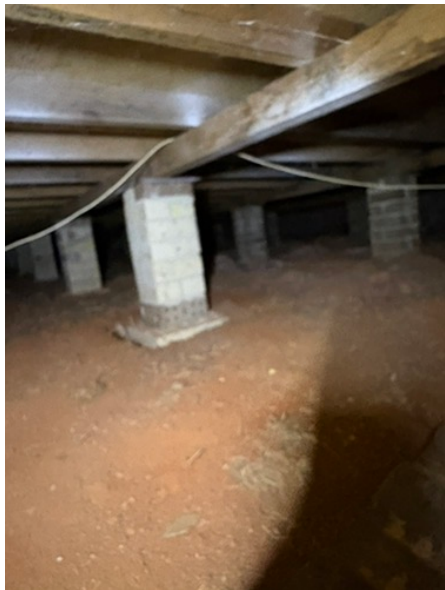
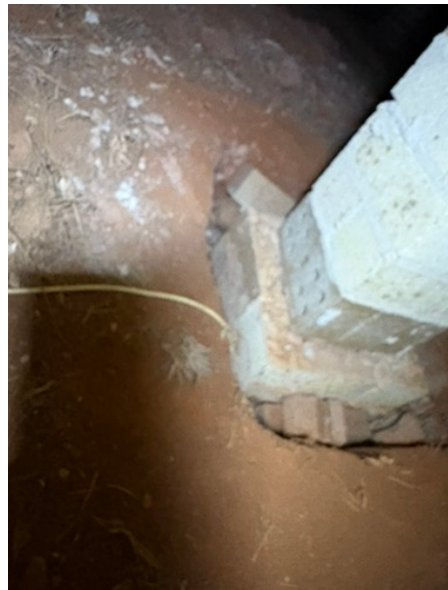
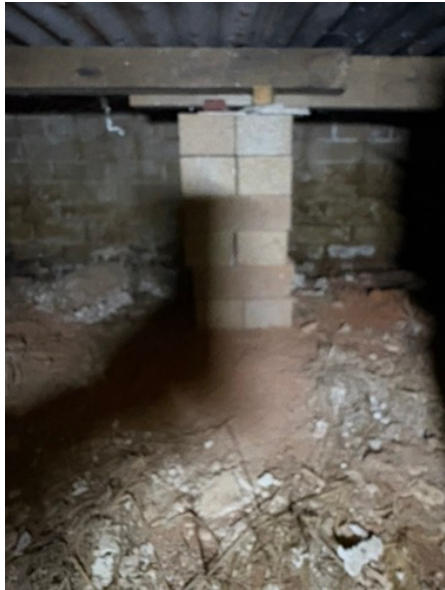
**Location:** Subfloor

The subfloor appeared dry at time of inspection. Ventilation appeared limited at time of inspection.

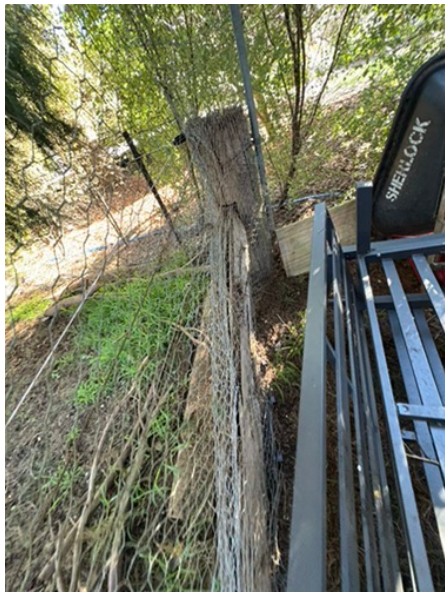
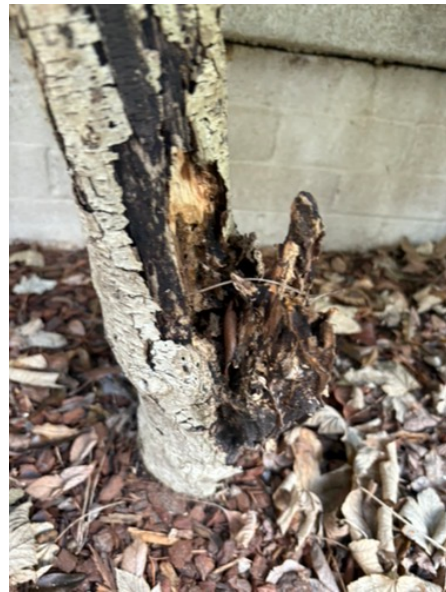
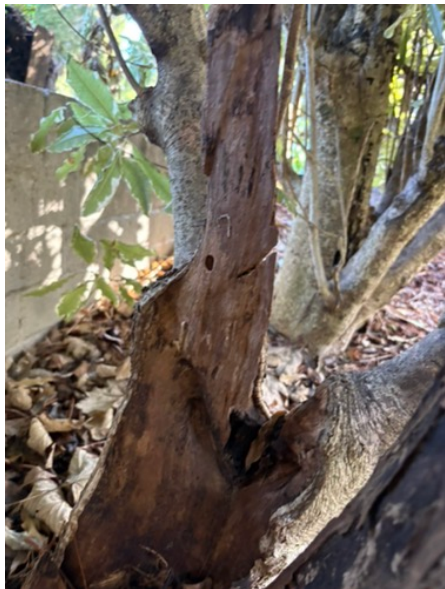
**Finding:** Wood rot

Wood rot which also known as Fungal Decay, occurs when timbers and other cellulose type building materials are exposed to damp conditions on a continual basis. Replacement of affected timbers may then be a necessary step in protecting surrounding building elements from such deterioration.

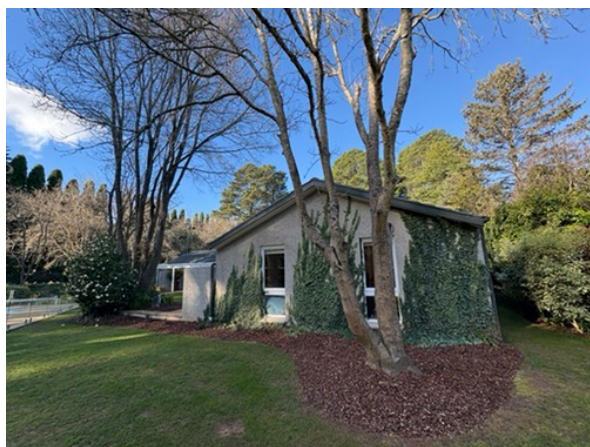
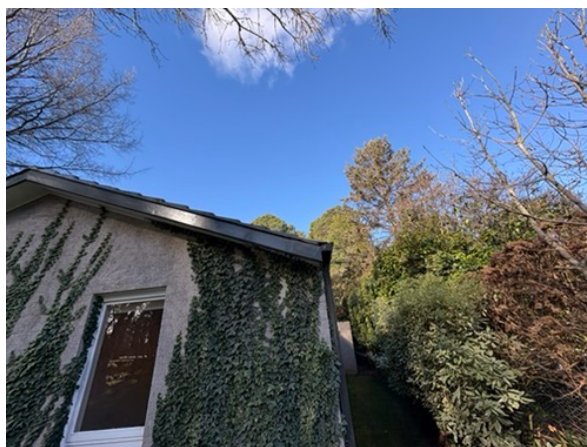
**Finding:** Vegetation adjacent to external walls

It is recommended to remove vegetation from the dwelling structure to reduce the possibility of invisible pest ingress.

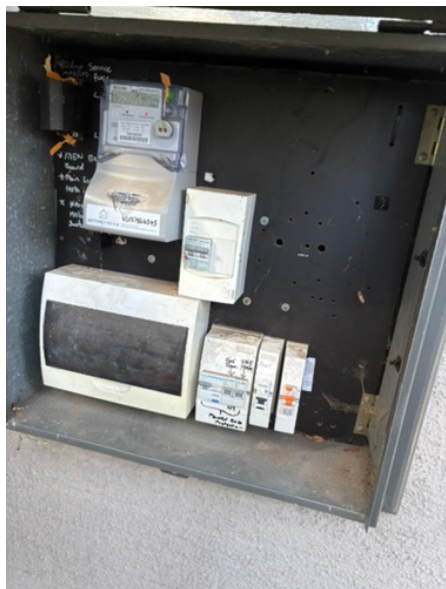
**Finding:** Termite Management System - no evidence of installation

A durable notice should be placed in the switchboard unit to indicate current termite barriers. At the time of inspection, it appeared as though no termite management system has been installed, with no evidence to suggest preventative works taking place. The client may consider gaining further advice from a pest controller as to the costs and procedures involved with this application. It is recommended that obtaining such advice be a short-term priority.
